Explosion Accident during Mobile Production of Bulk Explosives

Report by DSBs project committee on the follow up of the accident in Drevja on the 17th of December 2013

Published by: Norwegian Directorate for Civil Protection (DSB) 2015

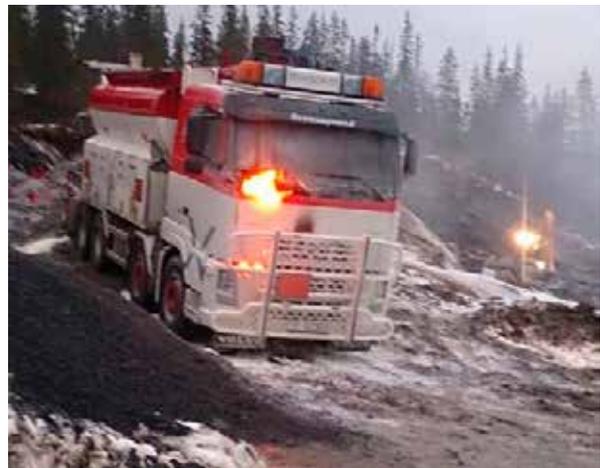
FIGURE 2. Picture of where the fire started.

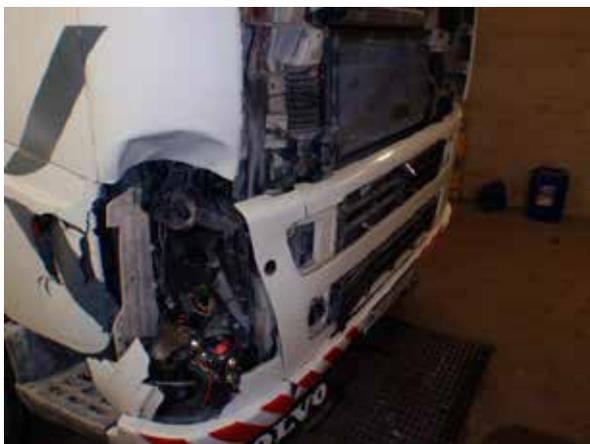
On 20th November 2013, F-114 was involved in a collision with three elks. The chassis received damages which were rectified in authorised garages, Volvo Car TTS and Dekksenter AS. There were damages related to the headlights and cables on the right side, to the car body and grille. Additionally a bull bar was fitted. The repairs were relatively comprehensive and in the order of 200,000 NOK. After the repairs, F-114 performed different charging missions. During these three charging missions, F-114 pumped a total of 26,895 kg without any non-conformances.

FIGURE 4. Picture of damages on MEMU F-114 after collision with the elks.

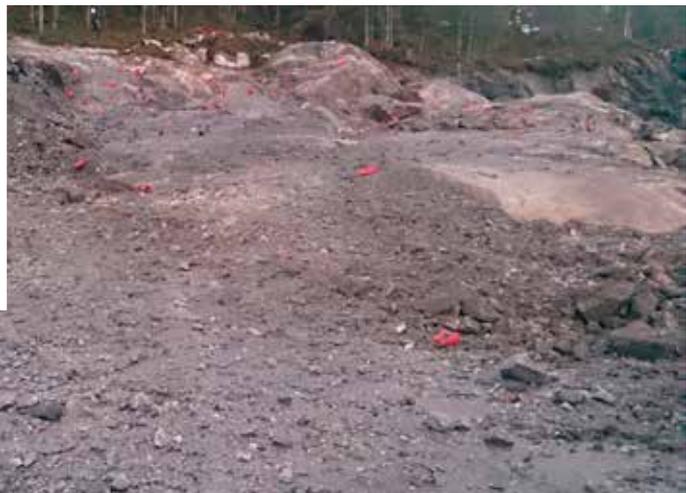
FIGURE 9. Explosion site after the explosion.

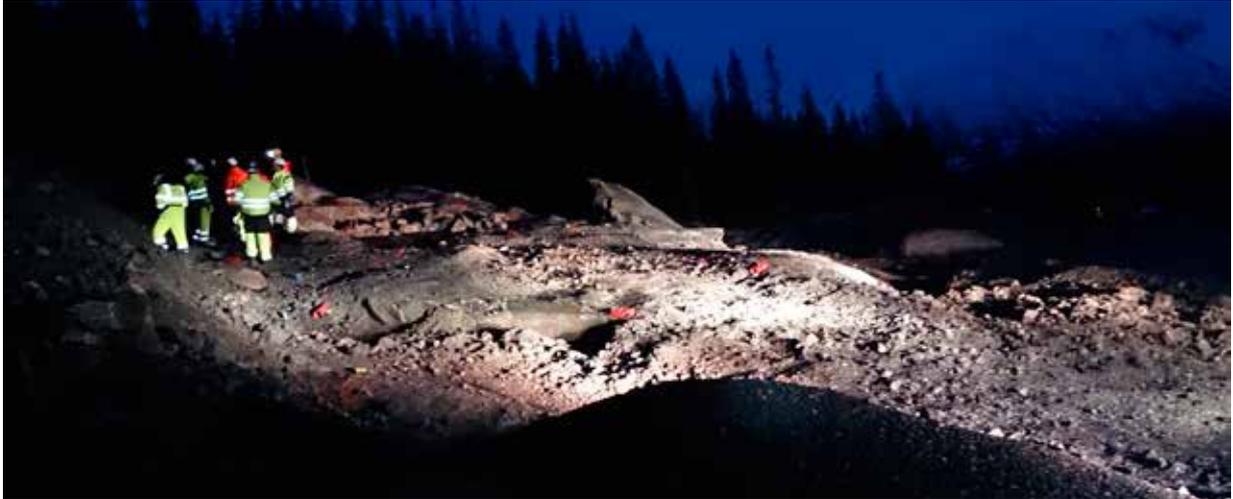
FIGURE 10. Picture that illustrates the effect of the blast on the crushed stones.

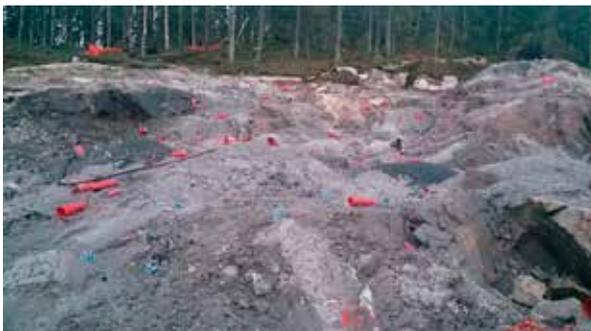
FIGURE 11. What it looked like on the blast area after the explosion.

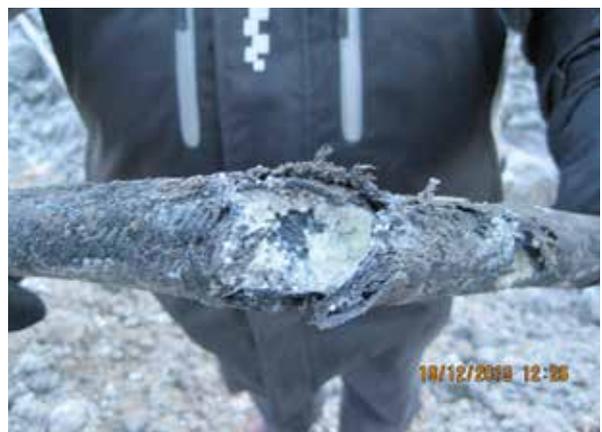
The hose which contained the mixed explosive material was found more or less intact approximately 40 meters from where the MEMU had been. The hose had a length of 84 meters in total where the first 60 meters starting at the outlet from the truck consisted of 1" reinforced rubber while the remaining 24 meters consisted of a 3/4" plastic charging hose which is lowered into the borehole. The content of the retrieved hose piece was sent to LOM (technical controlling authority) for analysis. The composition of the product was analysed, the sensitivity was tested according to the UN test series 3a and 3b and the thermal stability of the product was evaluated. The results were in conformity with the statement of compliance for the explosive RIOMEX SC 7000.

FIGURE 12. Picture of the hose with explosives.

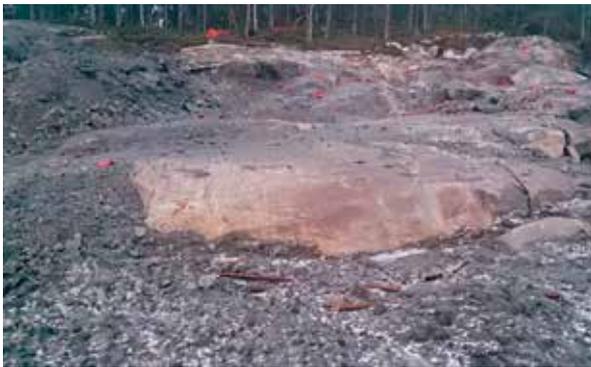
Figures 13 and 14 show that the rock surface at the explosion site had a distinct red coloring. The geologist from NPRA states that it is highly likely that this was caused by the incident.

FIGURE 13. Picture that demonstrates the red coloring on the rock surface.

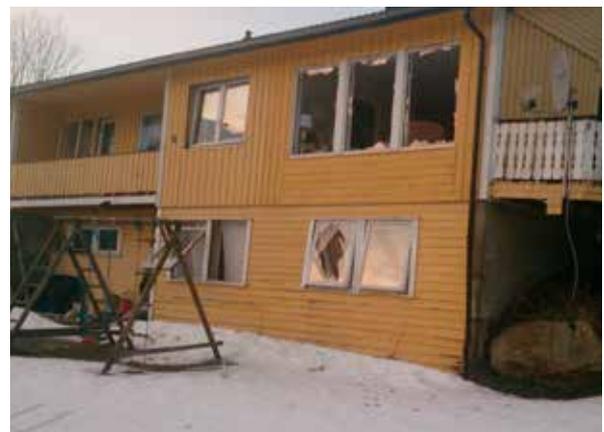
The pictures were analysed to find facades with several windows of the same type where only some of them were broken, since this indicates that the pressure and impulse values have been on the limit of what the windows can tolerate. The area and quality of the windows must then be evaluated in order to be able to estimate the pressure and impulse that the specific facade has been exposed to. A lateral pressure of 5 kPa can in most cases represent the pressure where windows can be broken. However, in some cases the pressure must exceed 10 kPa to achieve broken windows and some facades can even withstand pressure up to 15 kPa before 50% of the windows break.

FIGURE 15. Yellow house-wall facing south.

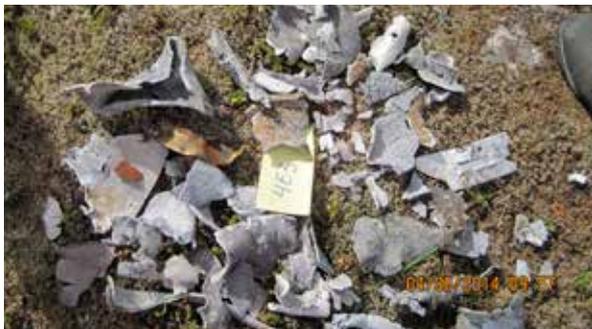
Small aluminum fragments, usually with a weight under 50 grams and an area down to 10 cm², were found up to 200 meters away from the explosion site. Fragments of such a small size, will only travel this far if the metal has been in direct contact with the explosive, as stated by FFI. It is only possible to reach the necessary initial velocity for such a trajectory if the metal and explosive is in direct contact during the detonation. The initial velocity must have been close to 100 m/s, which corresponds to the Gurney velocity which is approximately 30% of the detonation velocity.

FIGURE 20. Small aluminum fragments found at approximately 150 meter in easterly direction.

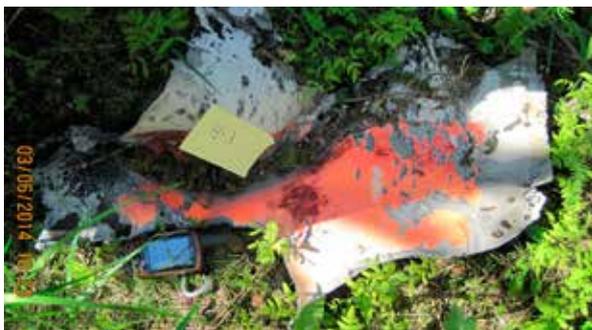
FIGURE 21. Big aluminum fragment found at approximately 170 meter in easterly direction.

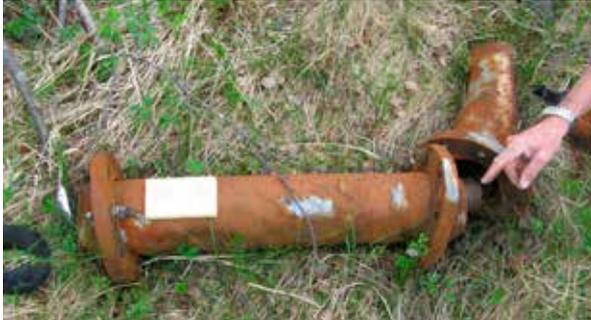
The augers and pump in the production unit is associated with explosive hazards if a pressure build-up caused by confinement is present. The product pump, the vertical auger and the horizontal mixing auger were all retrieved in a more or less intact condition and did not seem to have been exposed to any internal explosions.

FIGURE 22. Product pump.

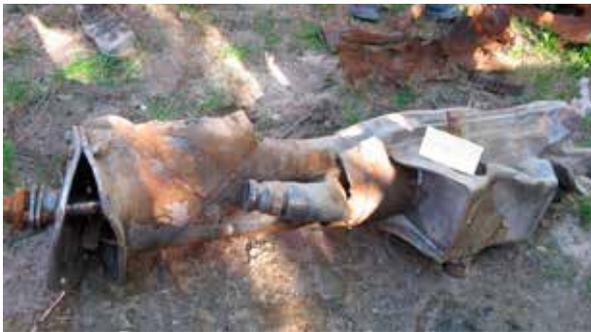
FIGURE 23. Horizontal mixing auger.

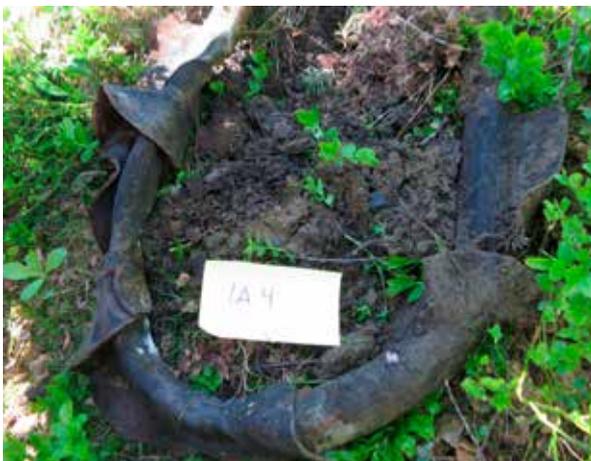
FIGURE 24. Part of the vertical auger.

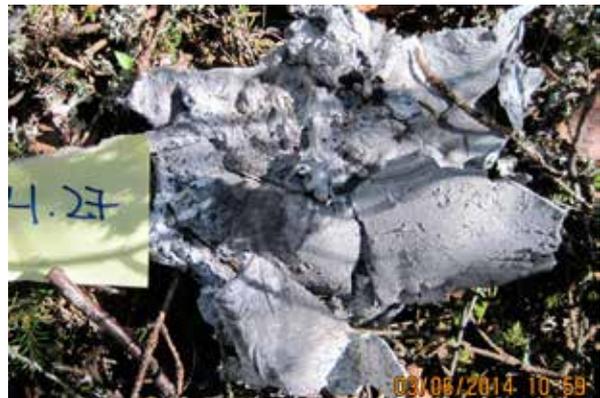
As mentioned earlier, roughly 115 aluminum fragments were identified (around 90 kg) originating from the tanks, cabinet doors, cab and the plate beneath the production unit. This is a small fraction of the total amount of aluminum that could be found on a MEMU. The tanks and the plate both had a thickness of 5 mm. Some of the fragments appeared to be unaffected by the heat from the fire while others were melted into aluminum cakes (28 were found in total). The evaluation on the heat influence on the aluminum fragments have been performed by engineers from DSB and an engineer from Maxam, Spain. Metallurgic expertise has not been performed.

FIGURE 26. Melted aluminium.

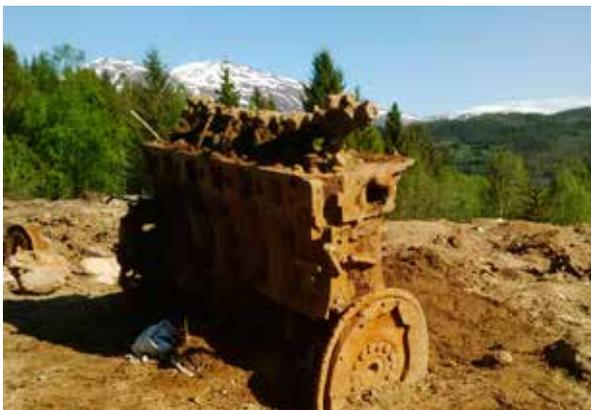
The intention of using aluminum tanks has been to reduce the probability of a fire leading to an explosion since the heat will weaken the aluminum tank, thus leading to rupture releasing the chemicals and relieving the pressure build-up. This incident does underline that the use of such aluminum tanks are not sufficient to prevent an explosion when exposing a MEMU to fire.

FIGURE 27. The engine block.

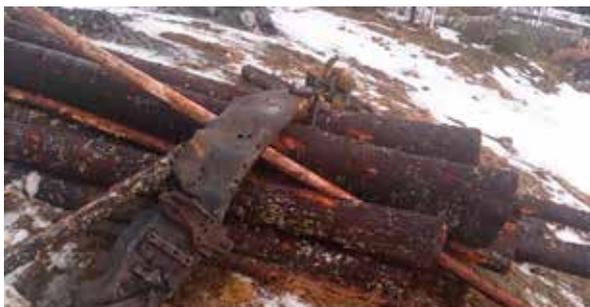
Another relevant issue is that diesel burns more intensively than e.g. rubber or plastic. This intensive burning will produce extremely high temperatures.

FIGURE 28. Fragment that illustrates deformation of steel due to heating.

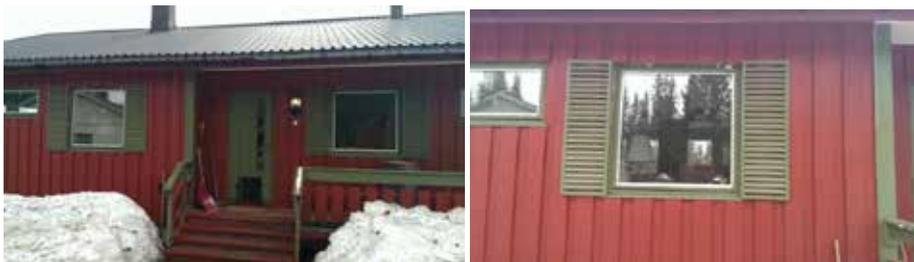
Nordside. Vindu skjøvet inn. Kun vindu i dør som er knust.

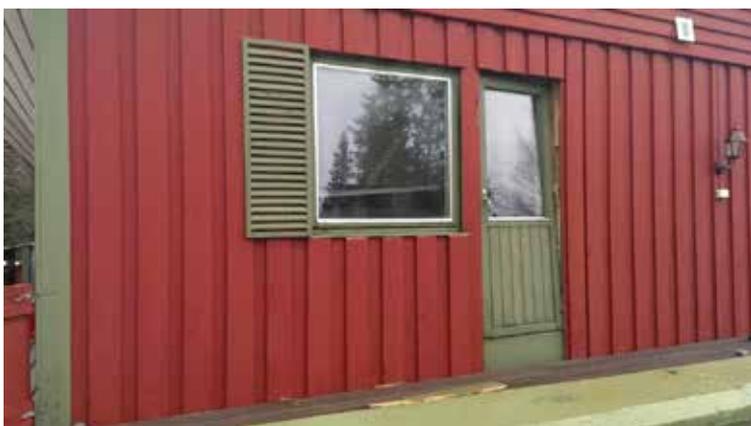
Vestside. Dør presset inn.

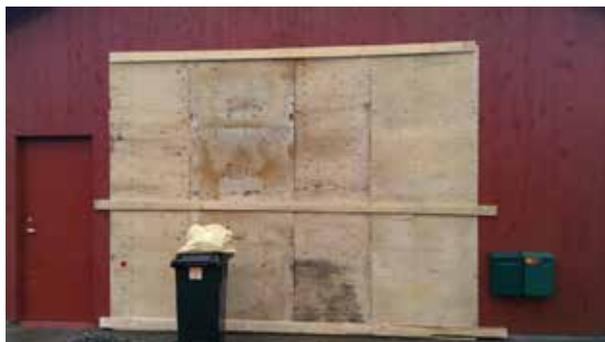
Vegg mot nord. Port trykket inn.

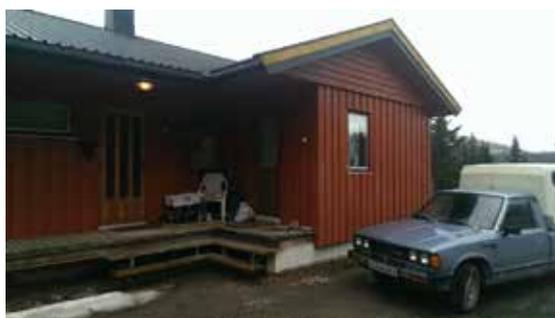
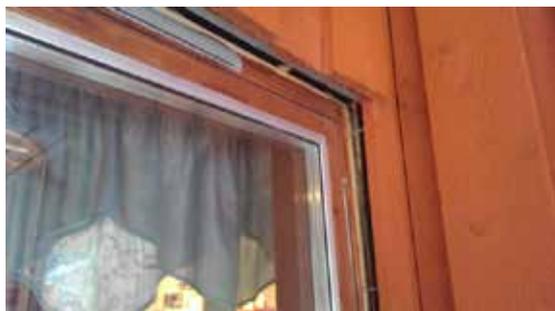
Fasade mot nord. Ingen knuste vinduer, men skjovet inn + strukturelle skader inne.

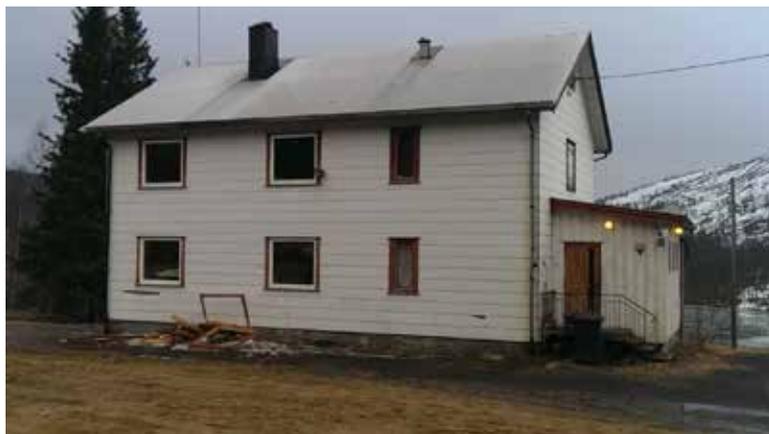
Nordside. De fire store vindu knust, de to små hele.

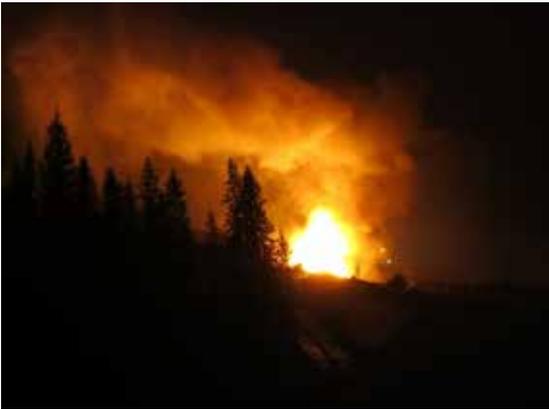
<p>Intensivering av brannen.</p>
