Explosion Accident during Mobile Production of Bulk Explosives

Report by DSBs project committee on the follow up of the accident in Drevja on the 17th of December 2013

Published by: Norwegian Directorate for Civil Protection (DSB) 2015

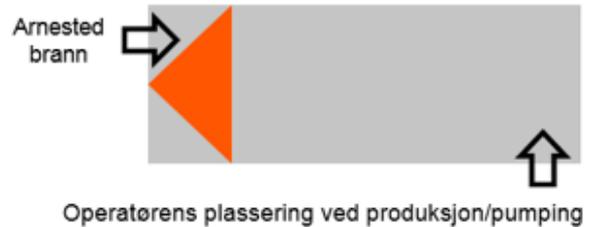
At approximately 13:00 the power supply shut down. The operator heard the characteristic sound of “(compressed) air leakage” whereafter the engine shut down immediately. The operator walked up to the cab and discovered white/grey smoke coming from the right front side of the vehicle. Subsequently, the operator went over to the passenger side and turned off the main power supply. When the operator opened the passenger door, the cab was filled with black smoke and visible flames were seen both on the in- and outside of the vehicle. The flames blazed towards the operator from the dashboard from the floor and up.

FIGURE 1. Where the operator stood in relation to the fire.

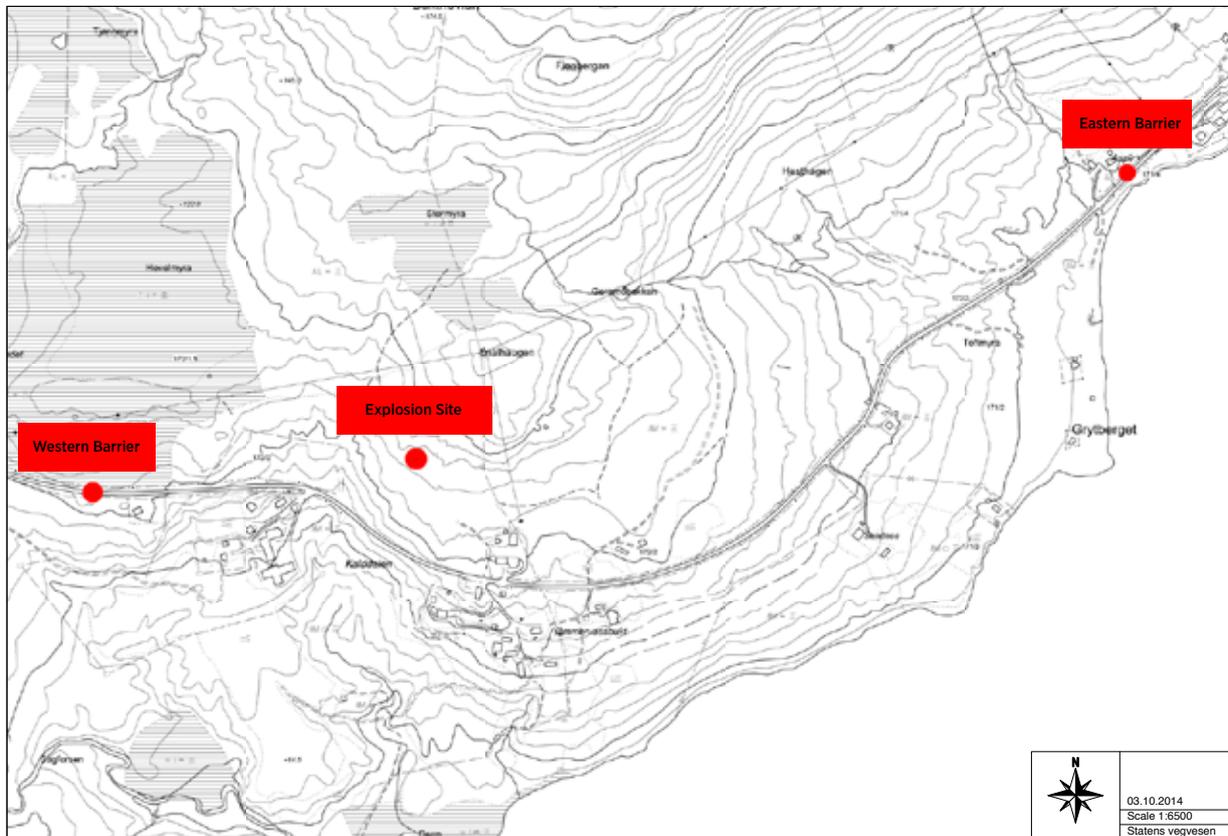
FIGURE 3. Map displaying the position of the MEMU and the eastern and the western barrier.

The map (Figure 3) displays the position of MEMU F-114 and the eastern and western barrier. The police executive, employees at the NPRA and the Maxam operator were situated at the eastern barrier, while employees from Johs. J. Syltern, the police, NPRA and the fire brigade chief was located at the western barrier.

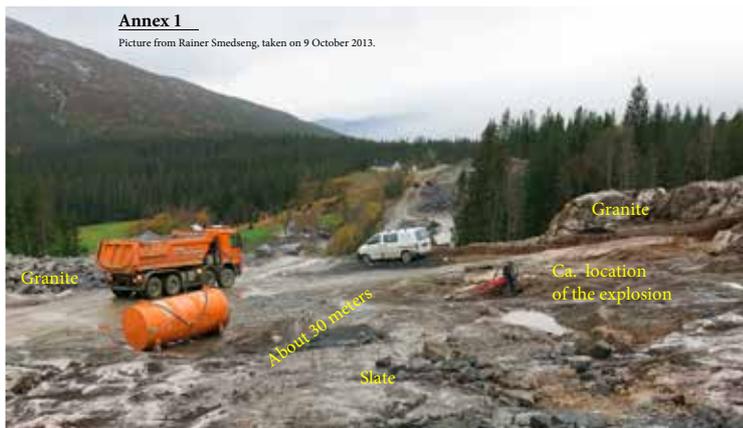
The effect of an explosive is dependent on confinement. Thus, the effect will be different if the explosive is placed in a borehole or on a surface. No tests, experiments or accidents have demonstrated a formation of a crater when detonated on a surface consisting of mica schist.

FIGURE 7. Picture illustrating the field of mica schist.

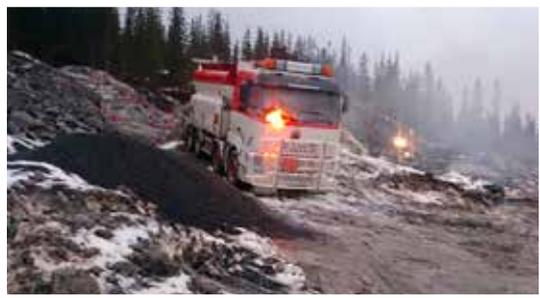
FIGURE 8. Explosion site before the explosion.

Figure 8 and 9 clearly demonstrates that the MEMU was considerably fragmented and that these fragments were immensely scattered by the explosion.

In Figure 8, a pile of crushed stones is seen to the left, next to and in front of the MEMU. During the first inspection on December 19th 2013, it was observed that this pile was less affected by the shock wave than what could be presumed. Figure 10 also illustrates this; however, it is difficult to give any accurate evaluations on these effects due to uncertainty in the distances at the site.

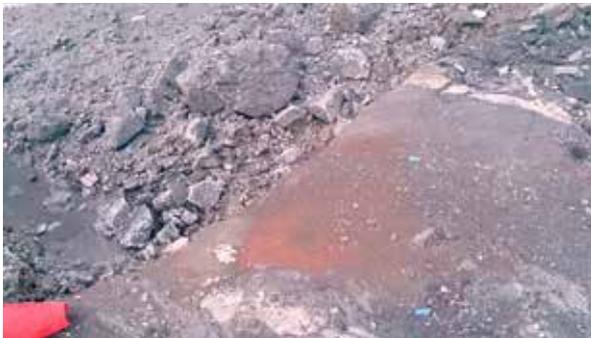
Figures 13 and 14 show that the rock surface at the explosion site had a distinct red coloring. The geologist from NPRA states that it is highly likely that this was caused by the incident.

FIGURE 14. Close up of the coloring.

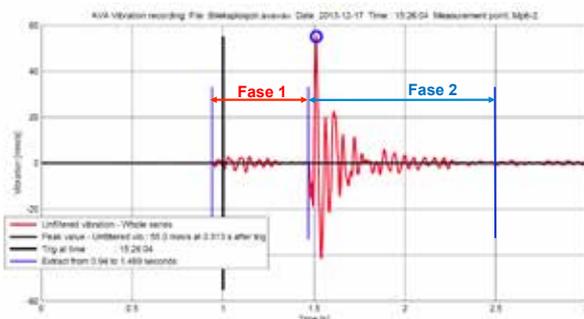
The measurements recorded during the explosion show two clearly separated phases – designated as

FIGURE 16. Registered seismographic measurements from the explosion in Drevja.

phase 1 and 2, respectively. NGI interoperate phase 1 to be vibrations which are transferred as mechanical waves from the explosion through the ground. Phase 2 are vibrations which are induced directly in and around the foundation when the air pressure from the explosion passes by.

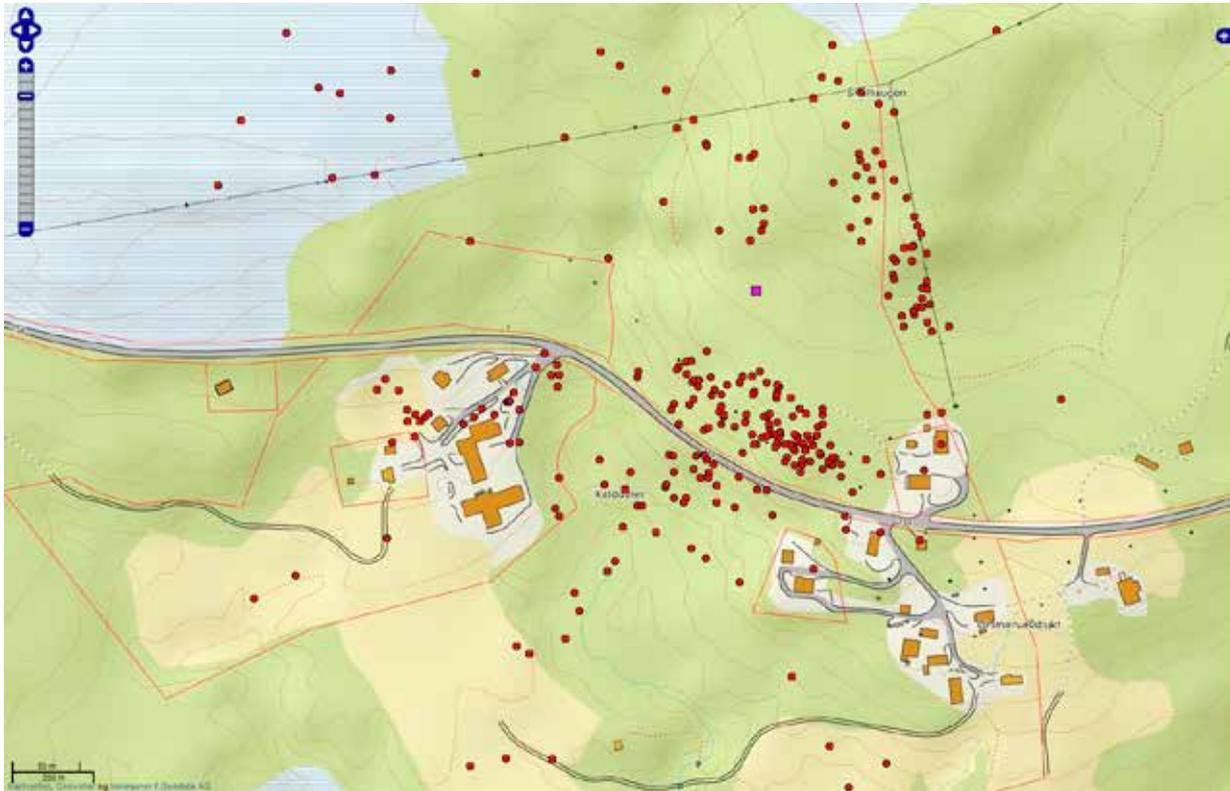
The fragments were found at distances from approximately 50 meters to around 500 meters. The map seen in the next figure shows a plot of all the registered fragments. The retrieved fragments varied considerably in weight, from aluminum fragments of a couple of grams to the engine block weighing around 900 kg.

Maxam has performed their own analyses based on the retrieved fragments as a part of their own individual report on this accident. Around 3,000 kg of the 9,000 kg of non-combustible material on the truck has been identified. Of these, around 30% of the total fragment count is aluminium, even though aluminium accounts for only 5% of the total weight. The remaining fragments are mainly of steel.

FIGURE 18. Map with plots of all the fragments. The pink square indicates the position of the MEMU.

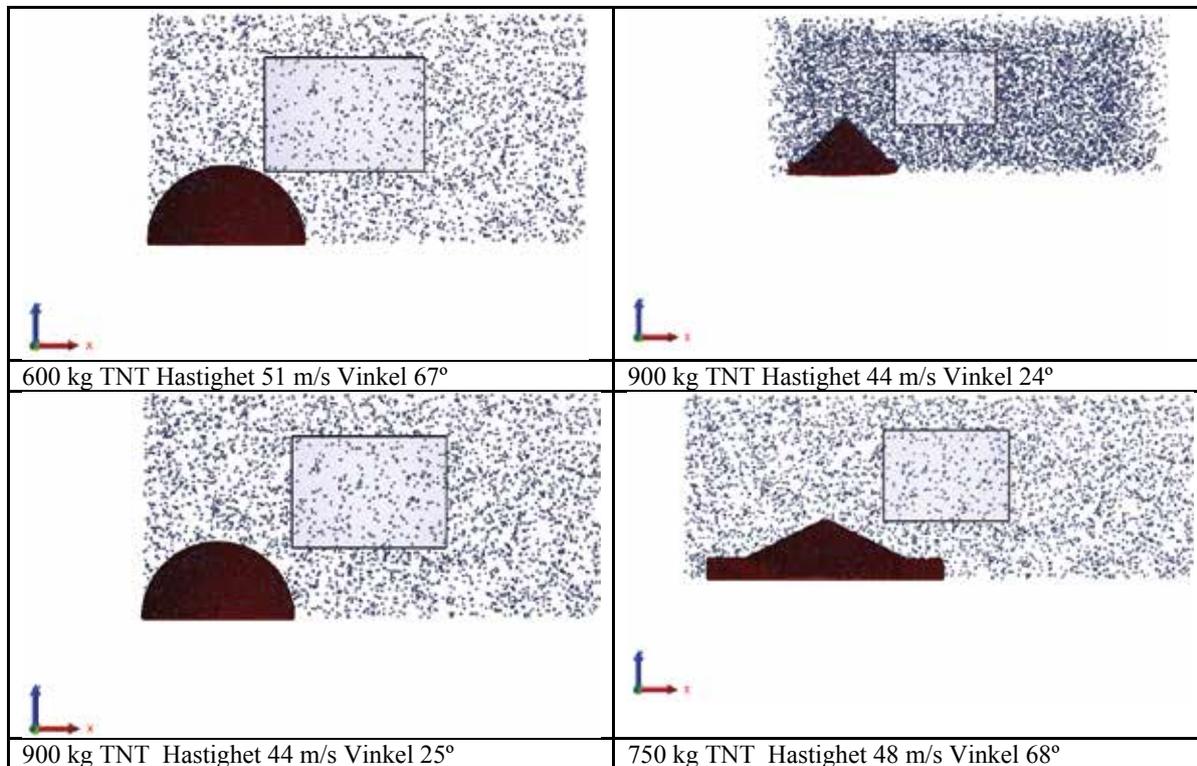
In the following figure, four different configurations can be seen where the combination of the shape, amount and positioning of the explosive and initial velocity and engine of the engine block provides the observed trajectory from the accident.

FIGURE 19. Four possible configurations that can result in the observed trajectory.

been used another outcome could be likely. A different configuration and positioning of the explosive could have shown different explosive yields. As an example, smaller amounts of explosive could have provided the necessary force if the explosive was partly placed directly beneath the engine.

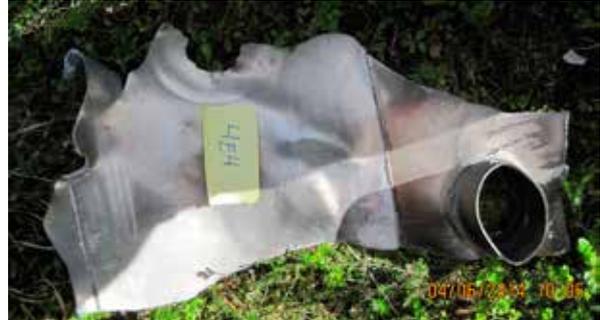
FIGURE 25. Fragment from the production diesel tank.

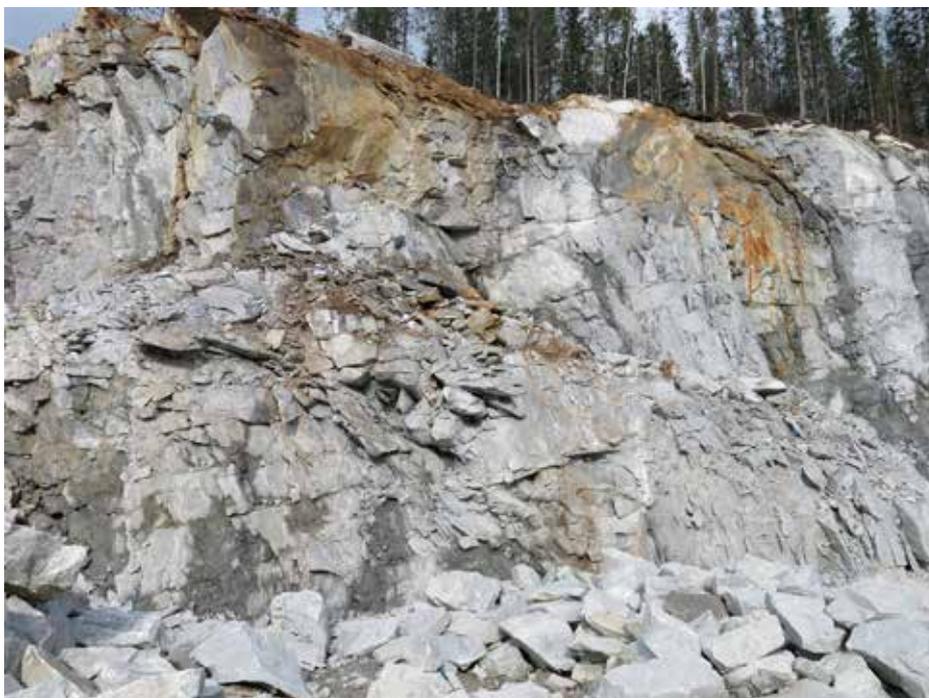
Foto 5: Bergvegg rett nord for der eksplosjonen skjedde. Hammer i nedre delen av bilde viser ca. hvor eksplosjonen vart. Bilde tatt den 25. september 2014.

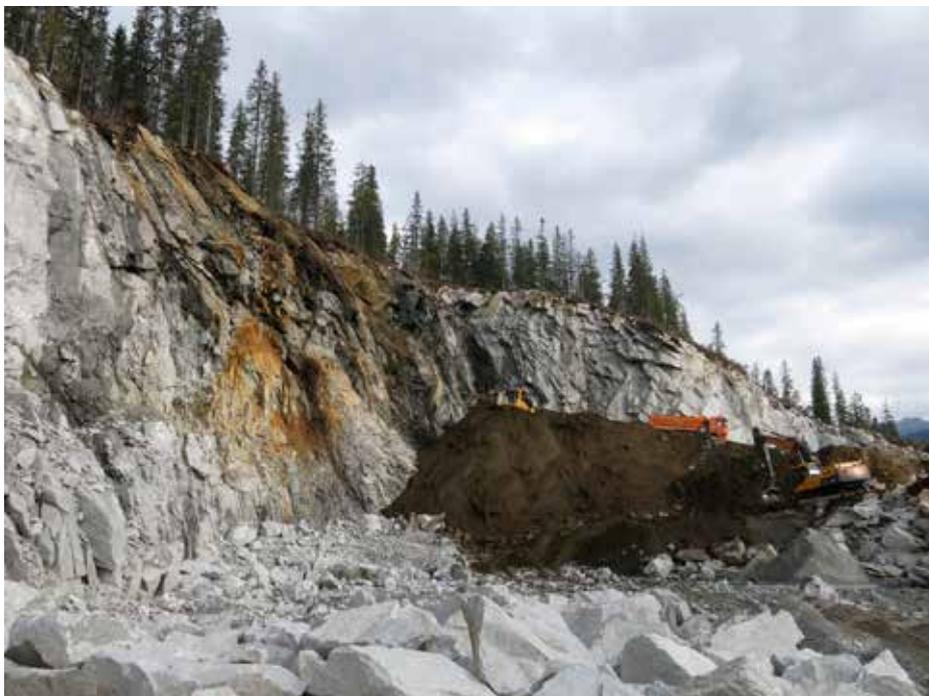
Foto 6: Sett fra eksplosjonssted mot fjellvegg i nordøst. Mørke fjellet er svakhetssonen som korse masseuttaket. Bilde tatt den 25. september 2014.

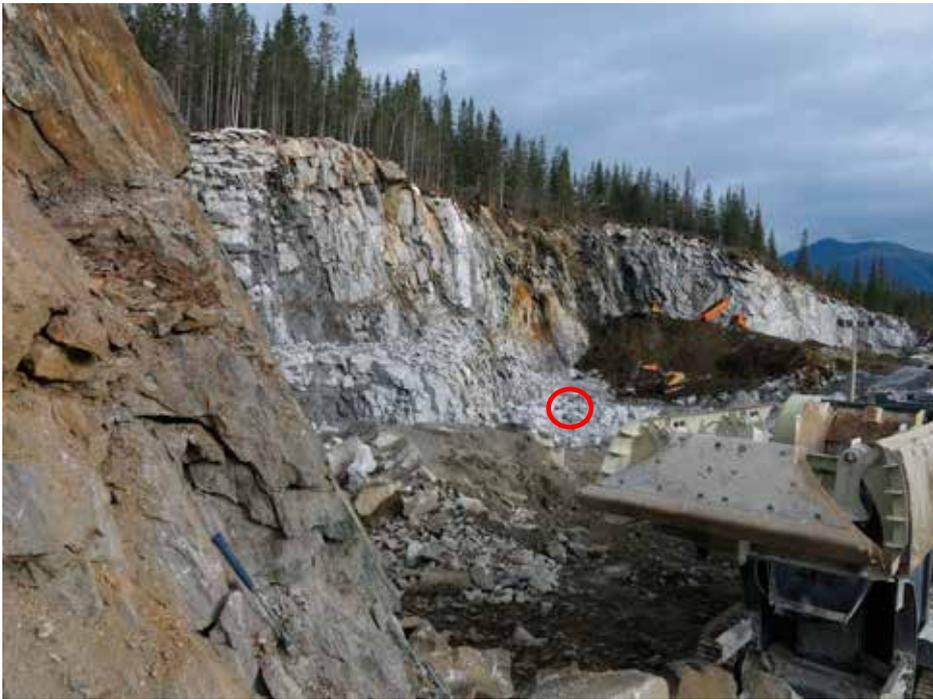
Foto 7. Bilde tatt fra pel ca. 4 810 mot nordøst. Fjellveggen sett på venstre side av bilde er av samme type berg som svakhetssonen sett på avstand, se foto 6. Stedet for eksplosjonen er omtrentlig innringet med rødt i bilde. Bilde tatt den 25. september 2014.

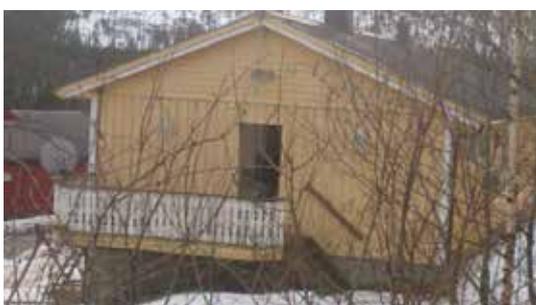
Kun dør på kortvegg. Blåst inn.

Kortvegg mot øst og ES. Dør blåst inn.

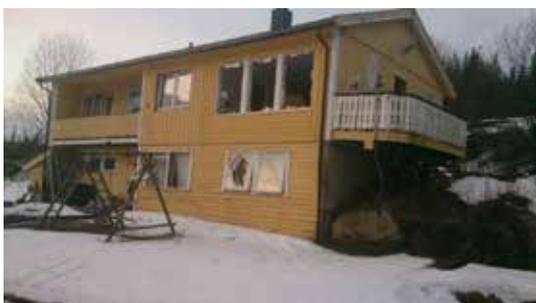
Langvegg: Tre av tre store vinduer knust. Halvparten av ”husmorsvindu” i 1.etg knust. Vindu i 2.etg skjøvet inn.

Langside mot sør. Vinduer knust. Vinduer skjøvet inn.

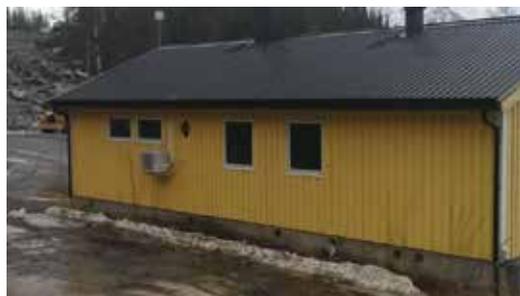
Langside nord. Ingen skader. ES opp til venstre.

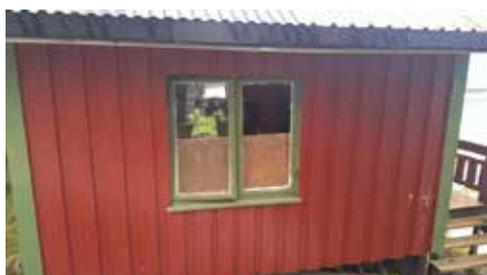
Bilde fra vest. Ett av to vindu knust. (Skjernet av typografi/vegetasjon?)

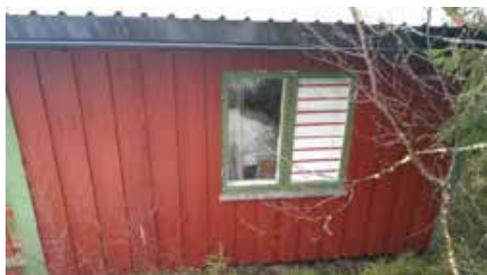
Bakside. Begge vindu hele.

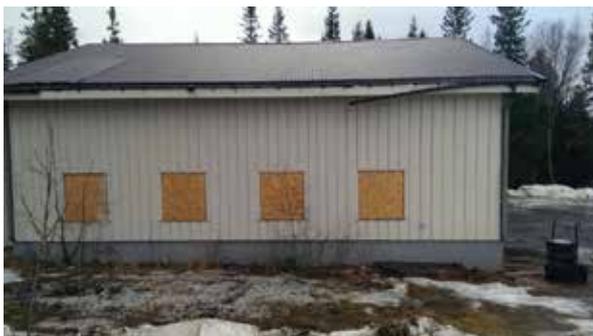
Langvegg mot vest. Fire av fire vindu knust. Takrenne henger.

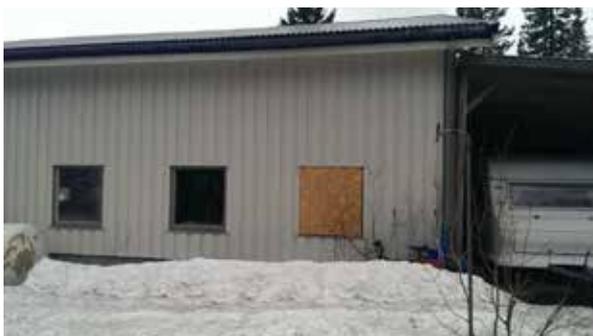
Bakvegg mot øst. Ett vindu knust (blåst eller sugd ut).

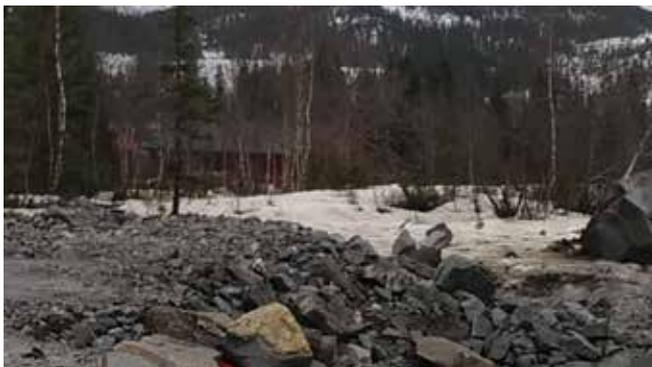
Langvegg mot nord, avstand 190 m, refleksjonsvinkel ca 40 grader.

Kortvegg mot vest, avstand 190 m, refleksjonsvinkel ca 50 grader.

Bilde. Retning fra nedenfor ES, mot husets nord og vestside.

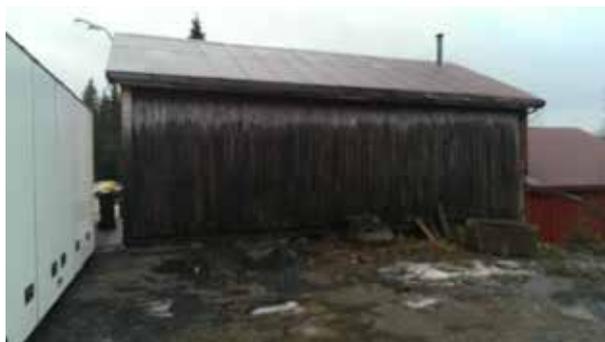
Sidevegg mot vest

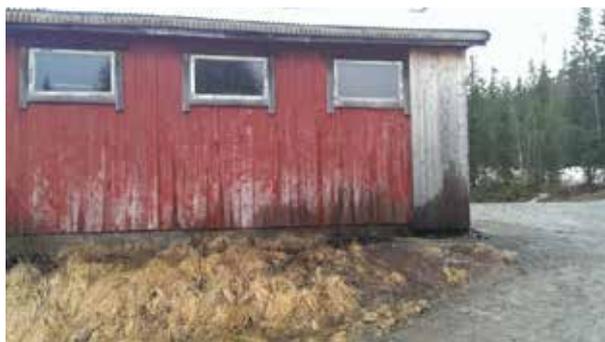
Sidevegg mot øst med vindu. Ingen knust.

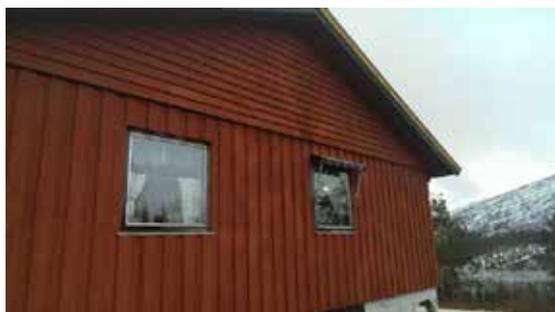
Fasade mot vest.

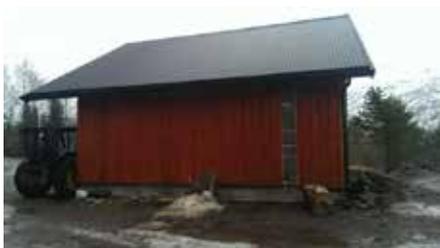
Fasade mot nord, avstand 202 m, refleksjonsvinkel ca 8 grader.

Fasade mot nord.

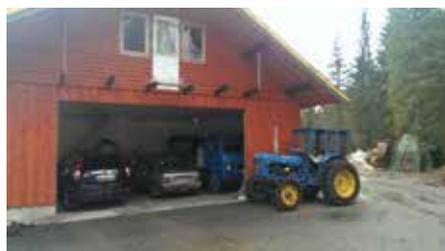
Fasade mot øst. Dør 2. etg vippet frem.

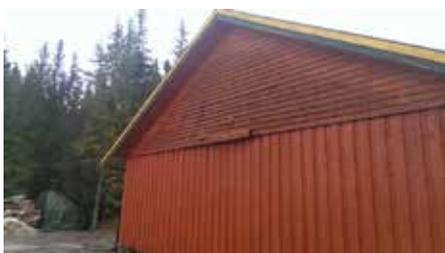
Fasade mot vest. Vegg buler.

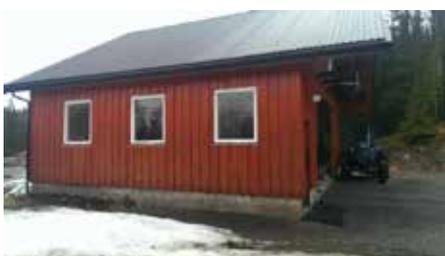
Fasade mot sør (bakside)

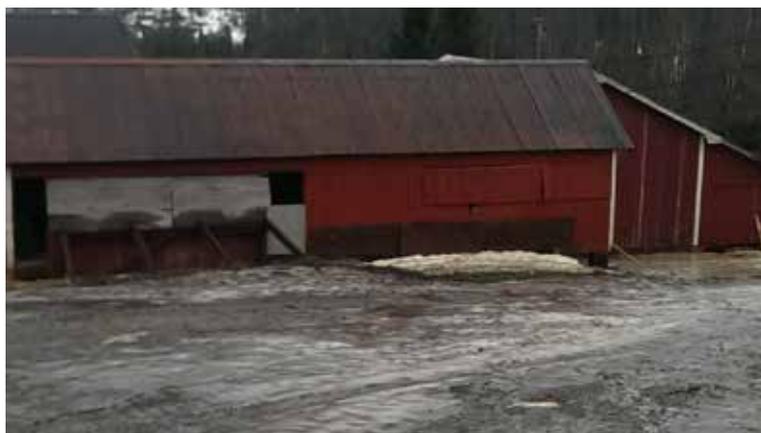
Langvegg mot nord, avstand 296 m, refleksjonsvinkel ca 30 grader.

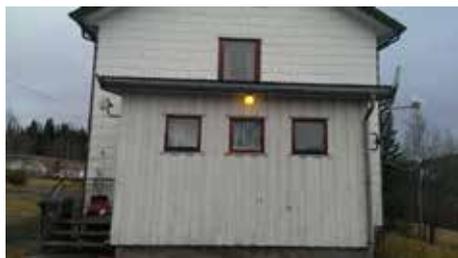
Vestvegg. Alle vinduer hele.

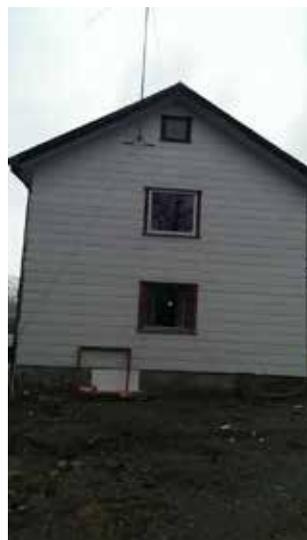
Østvegg. Ett av to vindu knust. (Blåst ut?)

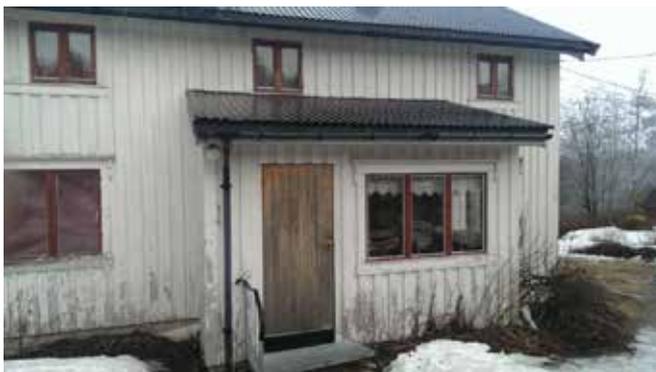
Fasade mot nord, avstand ca 337 m, refleksjonsvinkel ca 45 grader.

Fasade mot nord. Ingen skader.

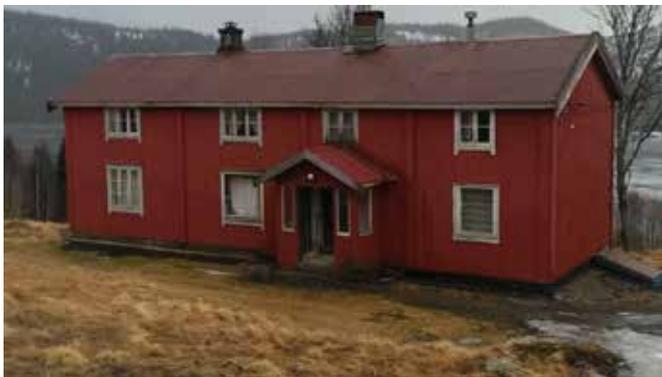
Langvegg mot nord, avstand 357 m, refleksjonsvinkel ca 30 grader.

Fasade mot nord. Ingen vindu knust (nå).

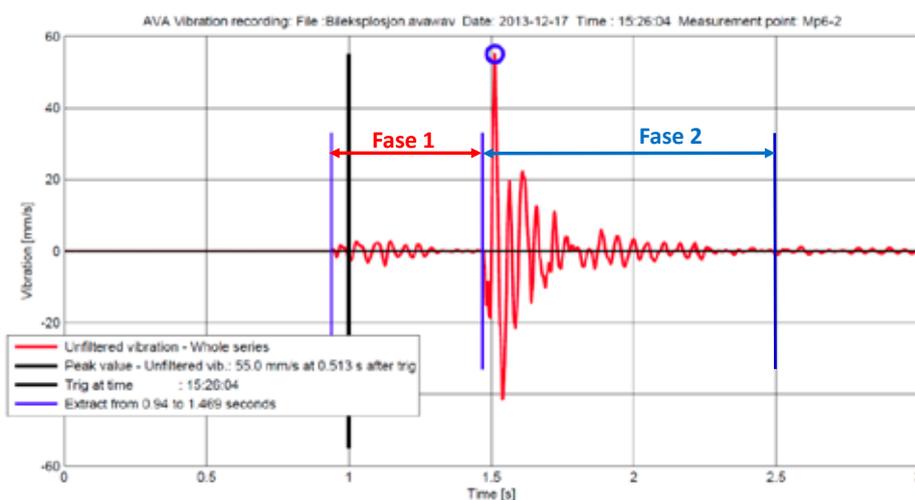
Figur 1 Registrert vibrasjonsforløp fra eksplosjon ved Dervja 17. desember 2013

Figur 1 viser vibrasjonsforløpet fra eksplosjonen, slik det er registrert av sensoren på grunnmuren i PM6-2.

Vår tolkning er at Fase 1 er vibrasjoner som er overført som mekaniske bølger fra eksplosjonen gjennom bakken, mens Fase 2 er bevegelser som er induert i bakken omkring grunnmuren og direkte i grunnmuren, i det lufttrykkbølgen fra eksplosjonen passerer. Dokumentasjon som underbygger denne tolkningen er gitt i det etterfølgende.

Fra plotten i Figur 1 kan vi lese av følgende målte differanse i ankomsttid til: $t_{diff_m\ddot{a}lt} = (t_{trykk_m\ddot{a}lt} - t_{vib_m\ddot{a}lt}) = (1.464s - 0.935s) = 0.529s$. Dette stemmer svært godt med den beregnede forventede forskjellen i ankomsttider. Det gir på denne måten en strek indikasjon på at vår tolkning av det registrerte vibrasjonsforløpet, at den første fasen – Fase 1 er mekaniske bølger, overført direkte gjennom bakken som Rayleighbølger, og at den andre fasen – Fase 2 er en umiddelbar respons av leire og grunnmur på ankomsten av lufttrykkstøtet fra eksplosjonen.

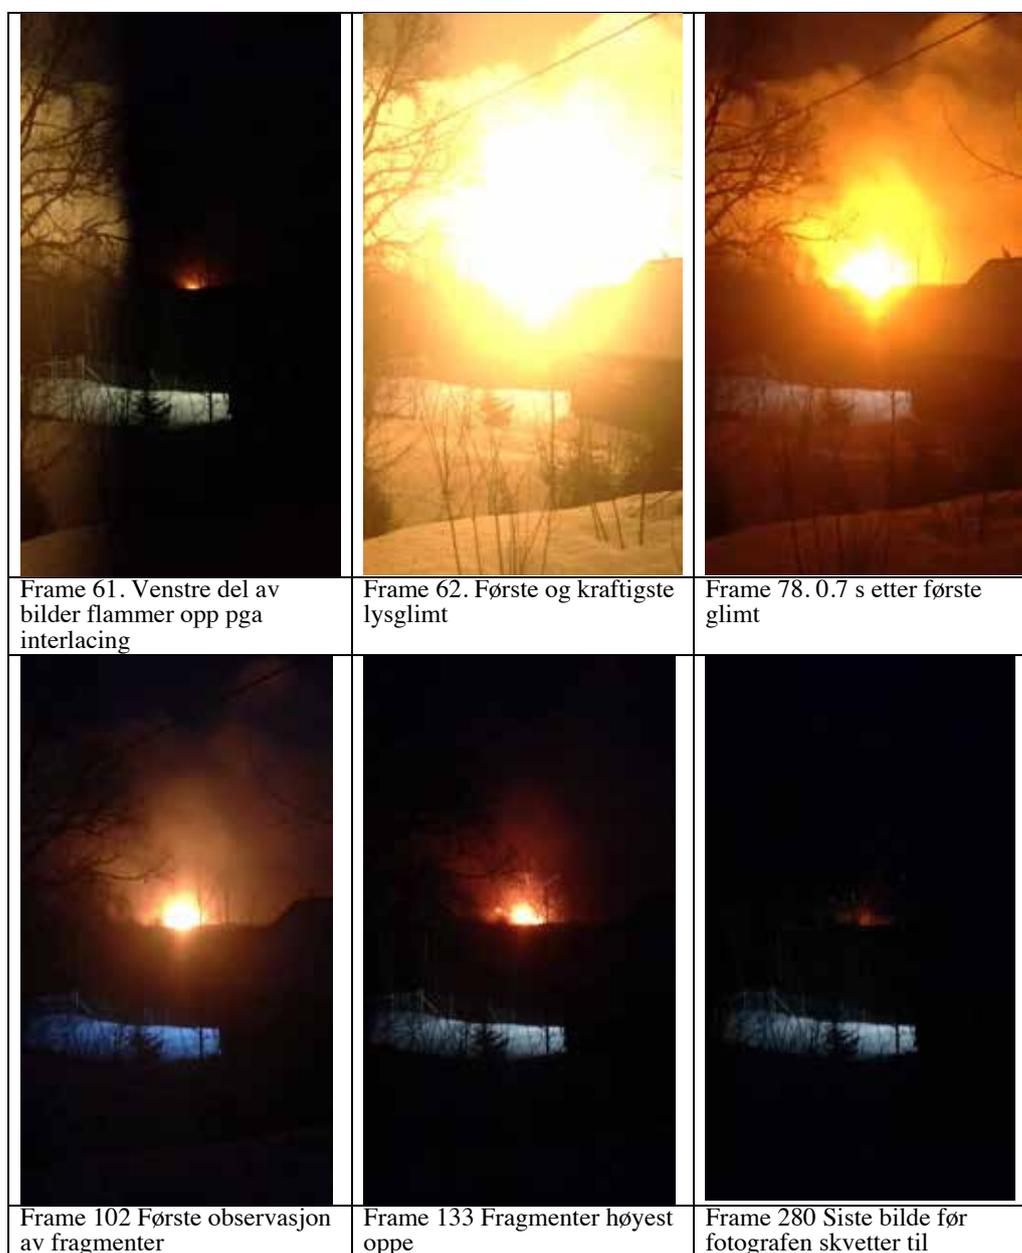
En analyse av dette viser at et aluminiumsfragment ikke ville kun nå opp i denne høyden med mindre det veier minst 1,5 kg, hvilket tilsvarer en størrelse på ca 40 x 40 cm når man antar at tykkelsen på flaket er ca 3 mm. Med denne vekten måtte utgangshastigheten ha vært ca 1270 m/s. Dette virker urealistisk, gitt den lave Gurney-hastigheten. Luftmotstanden til aluminiumsdelene kan også, som nevnt ovenfor, være noe undervurdert, hvilket forsterker konklusjonen om at de fragmentene vi ser ikke kan være aluminium.

Figur 1 Utvalgte bilder fra videoopptaket.

Det er derfor mest sannsynlig at det dreier seg om stålfragmenter på noen hundre gram. Et fragment på 300 gram kan nå denne høyden dersom utgangshastigheten er ca 700 m/s. Det vil nå toppunktet etter ca 6,5

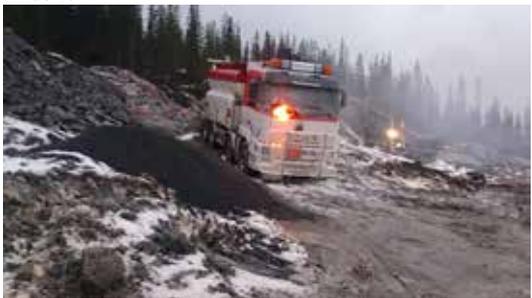
<ul style="list-style-type: none"> • Viser brannens arnested. • Flammer på høyre side av F-114 under frontruten og i tillegg er det to mindre flammer lengre ned på denne siden, ved grillen. • Rundt midten av fronten er det en tydelig avsetning av sot på oversiden av grillen. • Lyskasteren til høyre for bilen ble ikke slått av før evakuering.
kl 13:26 Brannen har vart i ca. 22 min.	Bilde 2:

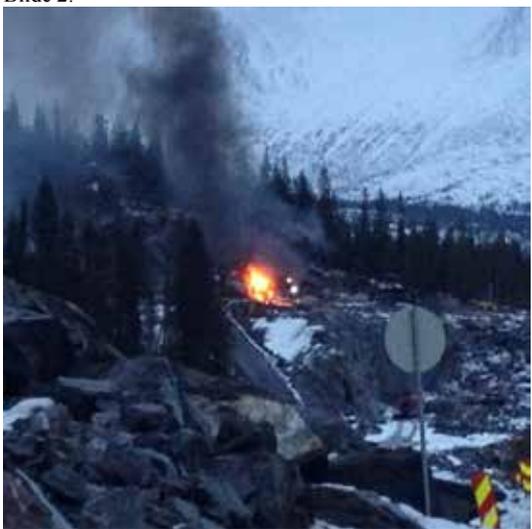
<ul style="list-style-type: none"> • Førerhuset er i full brann. • Ingen flammer på lasteplanet, deksel ses tydelig. • Ser ut til å brenne på bakken foran bilen. • Sort røyk kan tyde på forbrenning av plast, gummi, diesel og olje. • Lyskasteren ses til høyre for brannen.

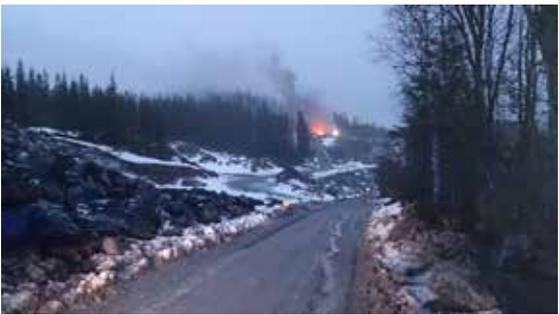
<p>Røyken er nå mindre sort og mer grå. Det kan tyde på at det er vanndamp i røyken. Vanndamp vil kunne gi hvit røyk, men sammen med sort røyk fra forbrenning av hydrokarboner kan røyken se mer grå ut.</p>
<p>Kl 14:23 Brannen har vart i ca. 1t 19 min</p>	<p>Bilde 4:</p>

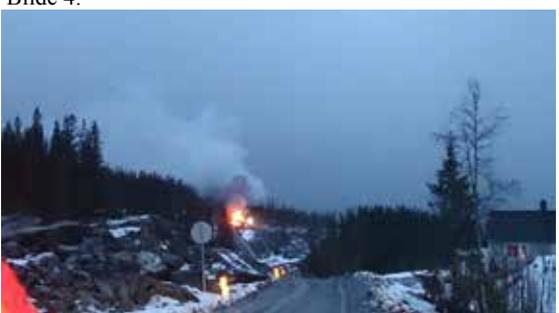
<p>Røyken ser mer grå og hvit ut enn på bilde tatt kl 14:06. Som nevnt tidligere kan hvit røyk tyde på at det er vanndamp i røyken. Vanndampen kan stamme fra både vanntanken på lasteplanet men også fra dekomponering av ammoniumnitrat.</p>
<p>Kl 14:30 Brannen har vart i ca. 1t 26 min</p>	<p>Bilde 5:</p>

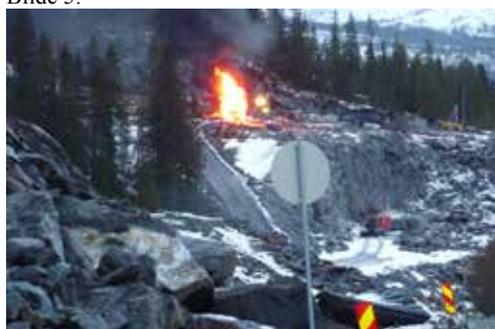
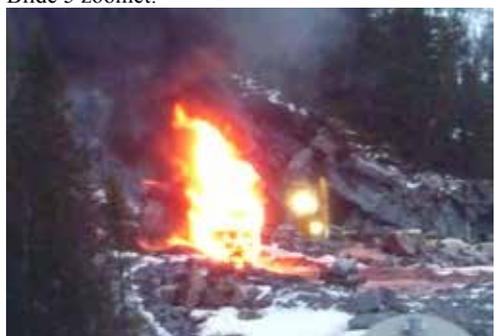
<p>Bilde 5 zoomet:</p>

<p>Ser ut som brannen ikke har nådd enden av lasteplanet, men at de bakerste bildekkene brenner.</p> <p>Ser ut som det brenner på bakken foran og ved siden av bilen. Kan være diesel, olje, smeltet plast og bildekk. Kan også tenkes å komme fra kjemikalier fra tankene om bord som har rent ut og brenner enten alene eller i kombinasjon med de tidligere nevnte materialer.</p>

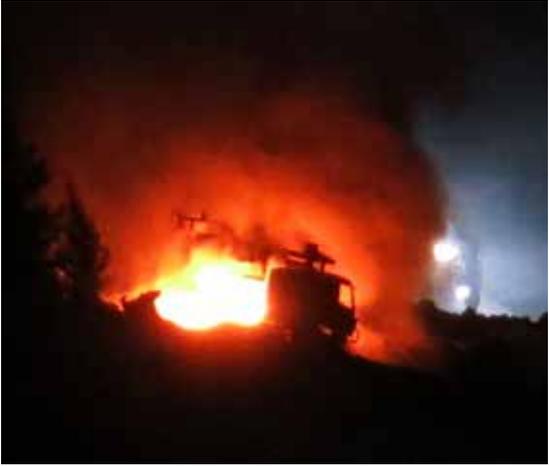
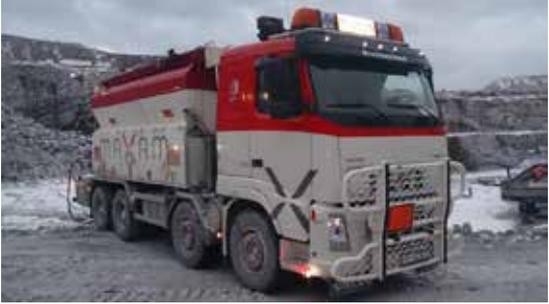
<p>K1 15:15 Brannen har vart i 2t 7 min</p>	<p>Bilde 6A:</p>

<ul style="list-style-type: none">• Ser ut til at førerhytta er utbrent.• Produksjonsenheten på lasteplanet er omsluttet av brann.• Ser ut til at horisontal skrue har falt litt ned når man sammenligner bilde 6A og 6B. Tyder på svikt i bæreegenskapene til aluminiumstankene.
<p>K1 15:21 Brannen har vart i 2t 17 min</p>	<p>Bilde 7:</p>

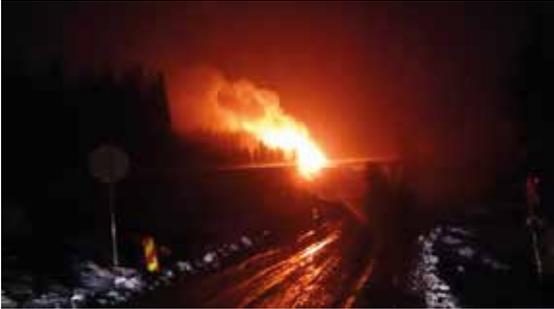
K1 15:26 Brannen har vart i 2t 22 min	Bilde 8:

Intensivering av brannen.
K1 15:26 Eksplosjonen	Bilde 9:

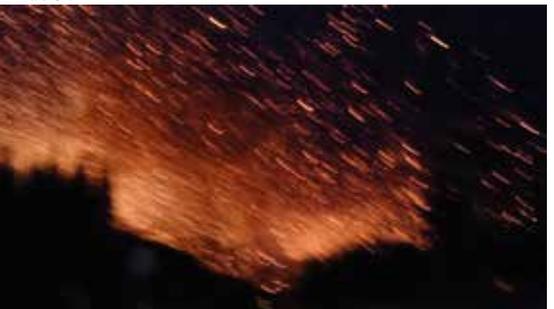
Brennende/glödende nedfall.
